DEPARTMENT OF TRANSPORTATION**DIVISION OF ENGINEERING SERVICES**

Quality Assurance and Source Inspection

Contract #: 04-0120F4Cty: SF/ALA Rte: 80 PM: 13.2/13.9File #: 69.28**WELDING INSPECTION REPORT****Resident Engineer:**Siegenthaler, Peter**Address:** 333 Burma Road**City:** Oakland, CA 94607**Report No:** WIR-023260**Date Inspected:** 03-May-2011**Project Name:** SAS Superstructure**OSM Arrival Time:** 700**Prime Contractor:** American Bridge/Fluor Enterprises, a JV**OSM Departure Time:** 1900**Contractor:** Zhenhua Port Machinery Company, Ltd (ZPMC), Changxing Island **Location:** Shanghai, China**CWI Name:** Liu Hua Jie.**CWI Present:** Yes No**Inspected CWI report:** Yes No N/A**Rod Oven in Use:** Yes No N/A**Electrode to specification:** Yes No N/A**Weld Procedures Followed:** Yes No N/A**Qualified Welders:** Yes No N/A**Verified Joint Fit-up:** Yes No N/A**Approved Drawings:** Yes No N/A**Approved WPS:** Yes No N/A**Delayed / Cancelled:** Yes No N/A**Bridge No:** 34-0006**Component:** OBG components.**Summary of Items Observed:**

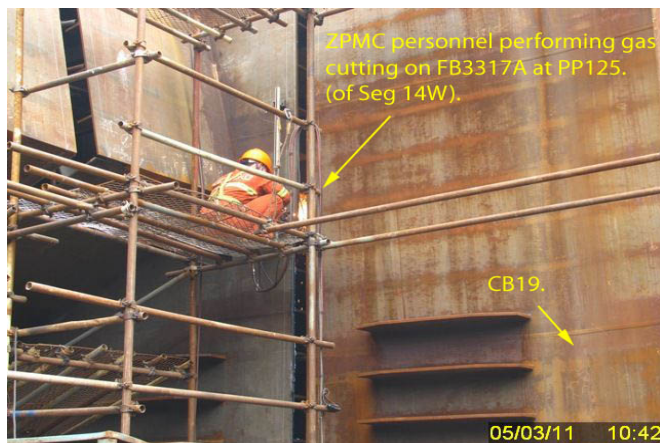
ZPMC personnel were performing gas cutting on Floor Beam (FB) 3317A. The alignment of Cross Beam 19 (CB19) to Seg 14W was in progress. See attached photo for further details.

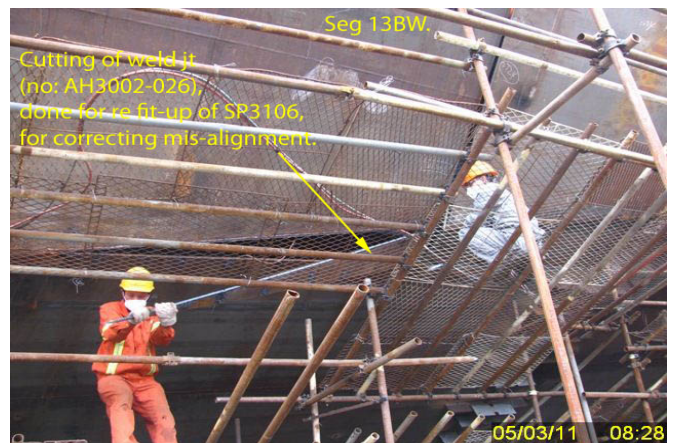
ZPMC personnel performing the oxy-fuel cutting of weld joint: AH3002-026 [of Architectural Housing (on Seg 13BW)]. The weld cutting operation was performed as per Weld Repair Report: WRR 20906 Rev-0. The fit-up of plate X-3398B was required to be performed with the side panel to correct the mis-alignment. See attached photo for details.
